# Tears on Extruded Edge

Learn how our Material Support & Solutions team solved this customer material issue.

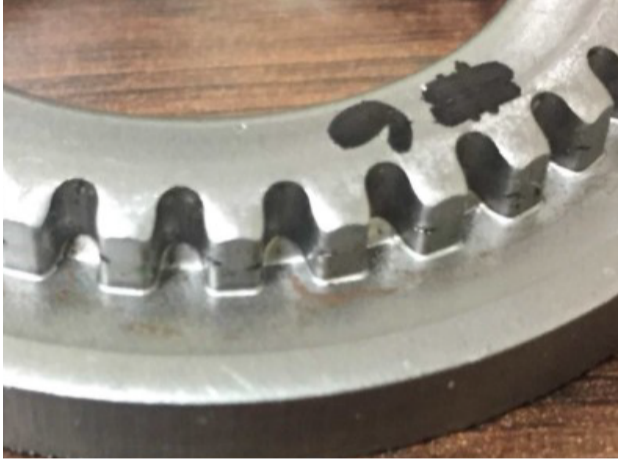
The customer experienced tearing on extruded teeth resulting in part rejection/sorting.

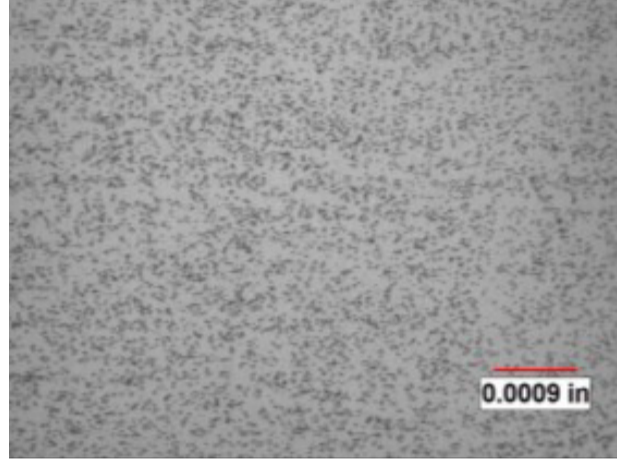
The microstructure and mechanical properties were analyzed to evaluate the steel. Two root causes were identified: incorrect die clearance and insufficient carbide spheroidization.
