Improved Steel Grade

Learn how our Material Support & Solutions team solved this customer material issue.

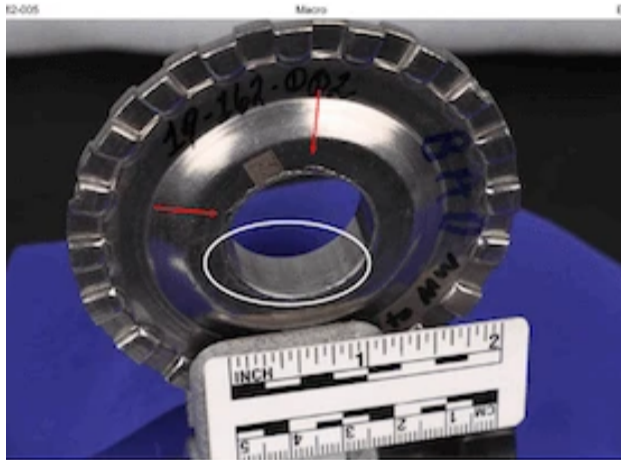
The customer was experiencing cracking and forming issues on a drawn part, resulting in additional lubrication and tooling modifications at their expense.

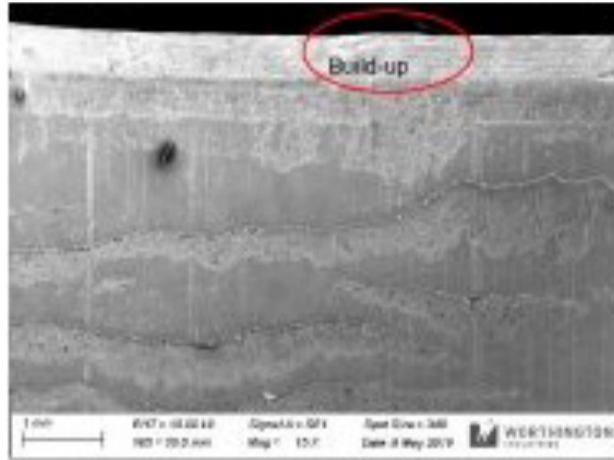
Our material's support team analyzed the steel's mechanical properties and chemistry, to determine the source of the cracking. The materials support team discovered that the customer's specification was wide, allowing for steel that was too hard for their application.
