Refining Material Grain Size

Learn how our Material Support & Solutions team solved this customer material issue.

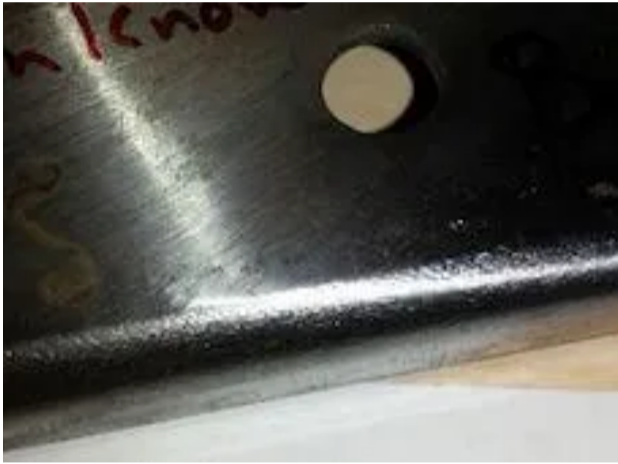
A customer expressed concern regarding an orange peel appearance on some of their support brackets. To compensate for this issue, the customer was paying for their formed parts to be buffed and polished to make their surface suitable for either chrome plating or high gloss black paint application.

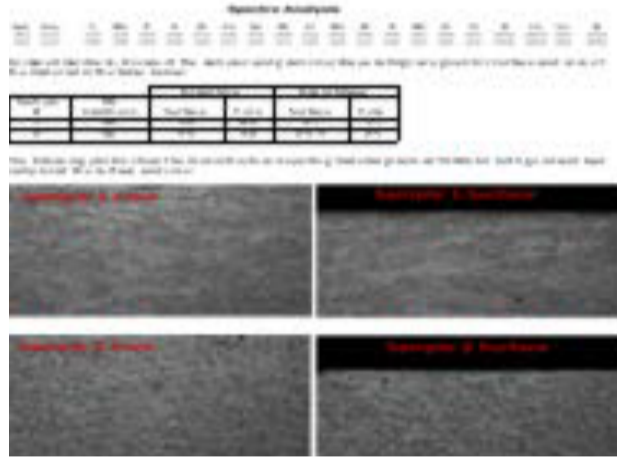
Worthington performed a microscopic examination of the material grain structure of the steel, and was able to indicate stark differences between the steel that produced orange peel and the steel that didn't. Comparing chemistry and hardness results with data from historical shipments indicated Worthington was not the supplier of the steel producing orange peel.

Our team determined that the cause of the orange peel was an overly large grain size. Control of the grain size, shape, and material hardness is paramount in limiting the orange peel effect. At Worthington, we go to great lengths in processing and analysis to ensure our steel has consistent properties for reliable outcomes.
